CHARACTERISTICS AND MANAGEMENT OF TIDAL IMPOUNDMENTS FOR WILDLIFE IN A SOUTH CAROLINA ESTUARY

ABSTRACT

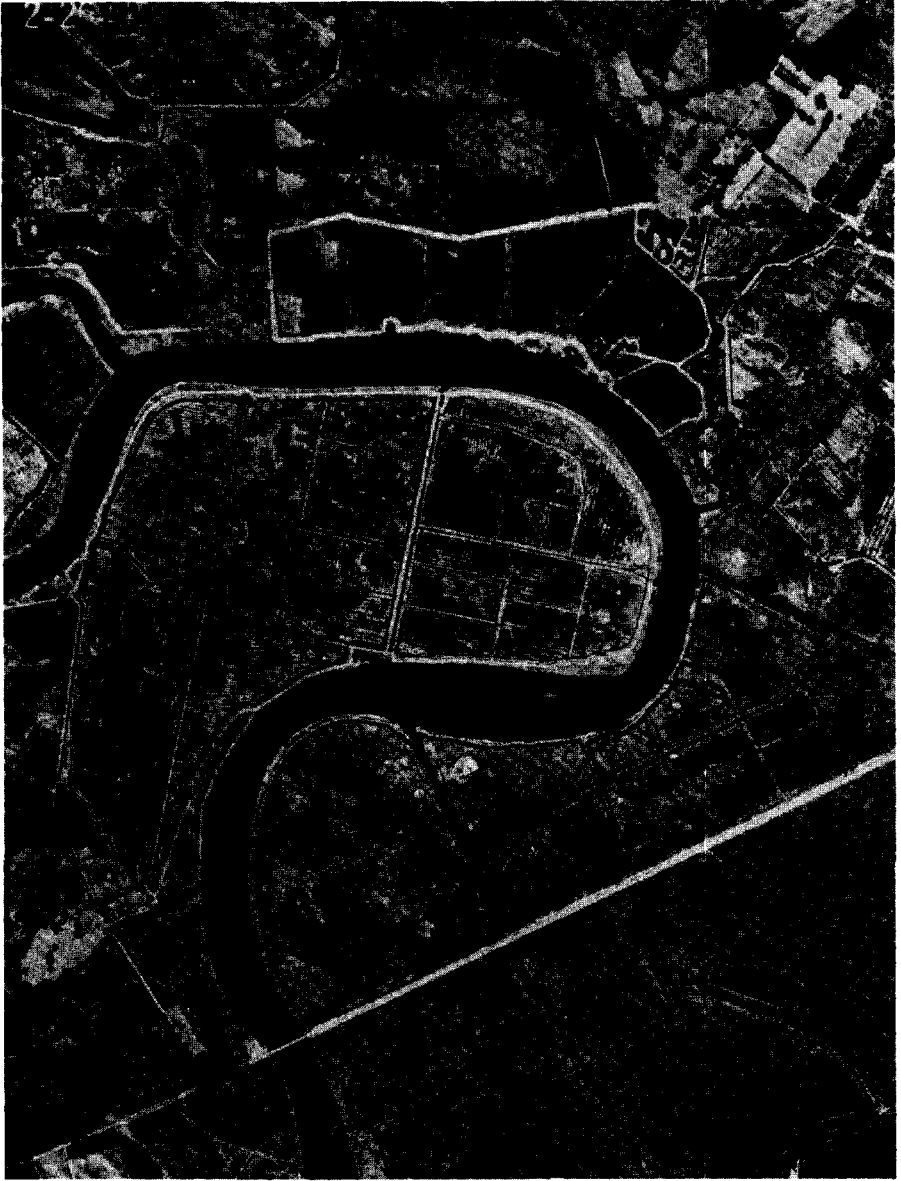
Fig. 2. Aerial photograph of an area on the Combahee River showing former rice fields: (A) maintained, (B) not maintained.

Inland swamps were first cleared for rice fields, and later freshwater tidal swamps were cleared. Both types of swamps were heavily timbered, predominantly with gum (*Nyssa* spp.) and cypress (*Taxodium* spp.). The rice field dikes and ditches in the inland swamps have been overgrown for many years, and, though readily noted during field inspection, were not easily discernible from aerial photographs at a scale of 1:20,000. Rice field complexes in the tidal areas, however, are easily distinguished on aerial photographs (Fig. 2).

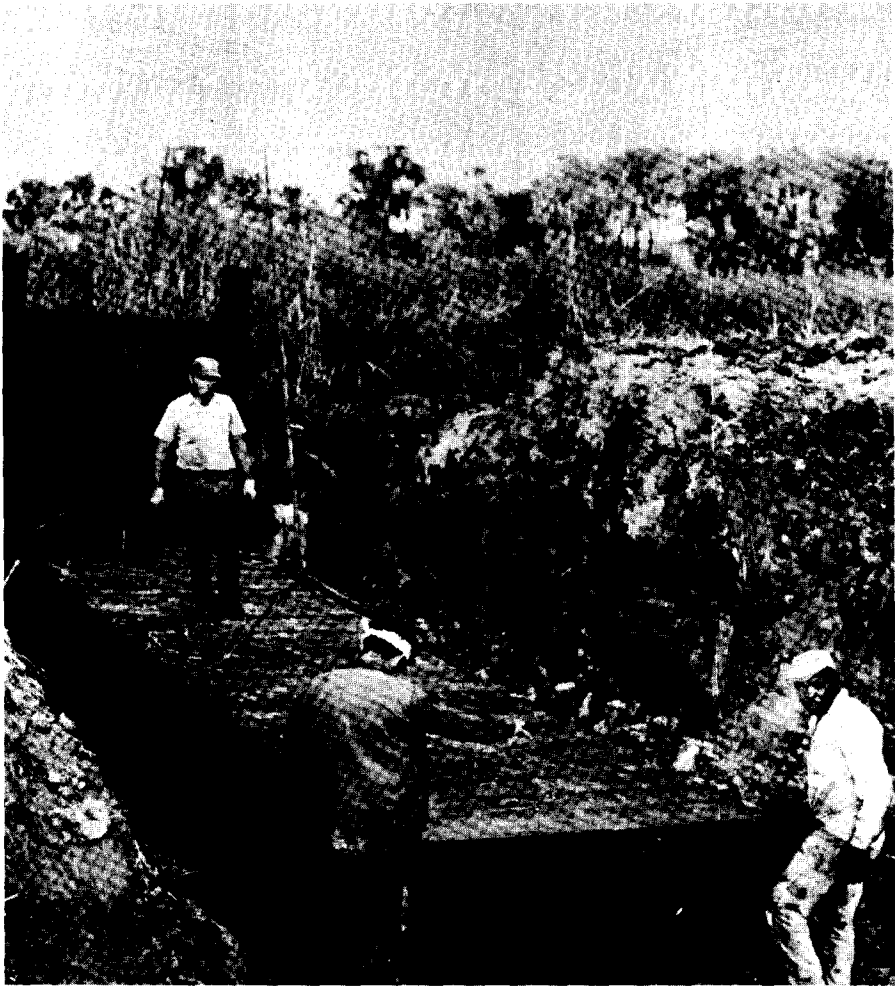
Fig. 6. Typical water control structure being installed at the Bear Island Game Management Area.

Wooden water control structures were of a design similar to the original rice field trunks (Figs. 5-6). The flap gates at both ends could be raised or lowered to take in or let out water with the tides. If water was needed, the gate outside the pond was raised. At high tide the force of the water pushed open the inside flap gate. When the tides subsided, the pressure of the water in the pond against the inside flap gate caused it to close. When drainage was desired, the inside flap was raised on an outgoing tide, and the force of the outward rushing water pushed open the outside gate.

Most modern water control structures also had a flash-board riser just behind the inside mouth permitting water levels to be maintained at the desired level. The riser consisted of a rectangular trough built perpendicular to the inside lip of the trunk, usually about 5 feet high, 5 feet wide and 1 foot deep. The side of the trough facing the pond was made of removable boards ("flash-boards" or "riser-boards") placed horizontally in grooves that ran the height of the "riser". With the inner gate shut, the water level of the impoundment could be regulated by adding or removing boards. The
